Condition Record: roofs and upper walls

Two Victorian terraced houses, four storeys, slate roofs behind parapets, two chimney stacks, rendered flank walls, rear outrigger. Seafront town, East Sussex. Address and client withheld in this sample.

PREPARED BY
Lloyd Jankielsohn, remote pilot, ASSET WING LTD · CAA Operator ID GBR-OP-QX978LRS2JLD

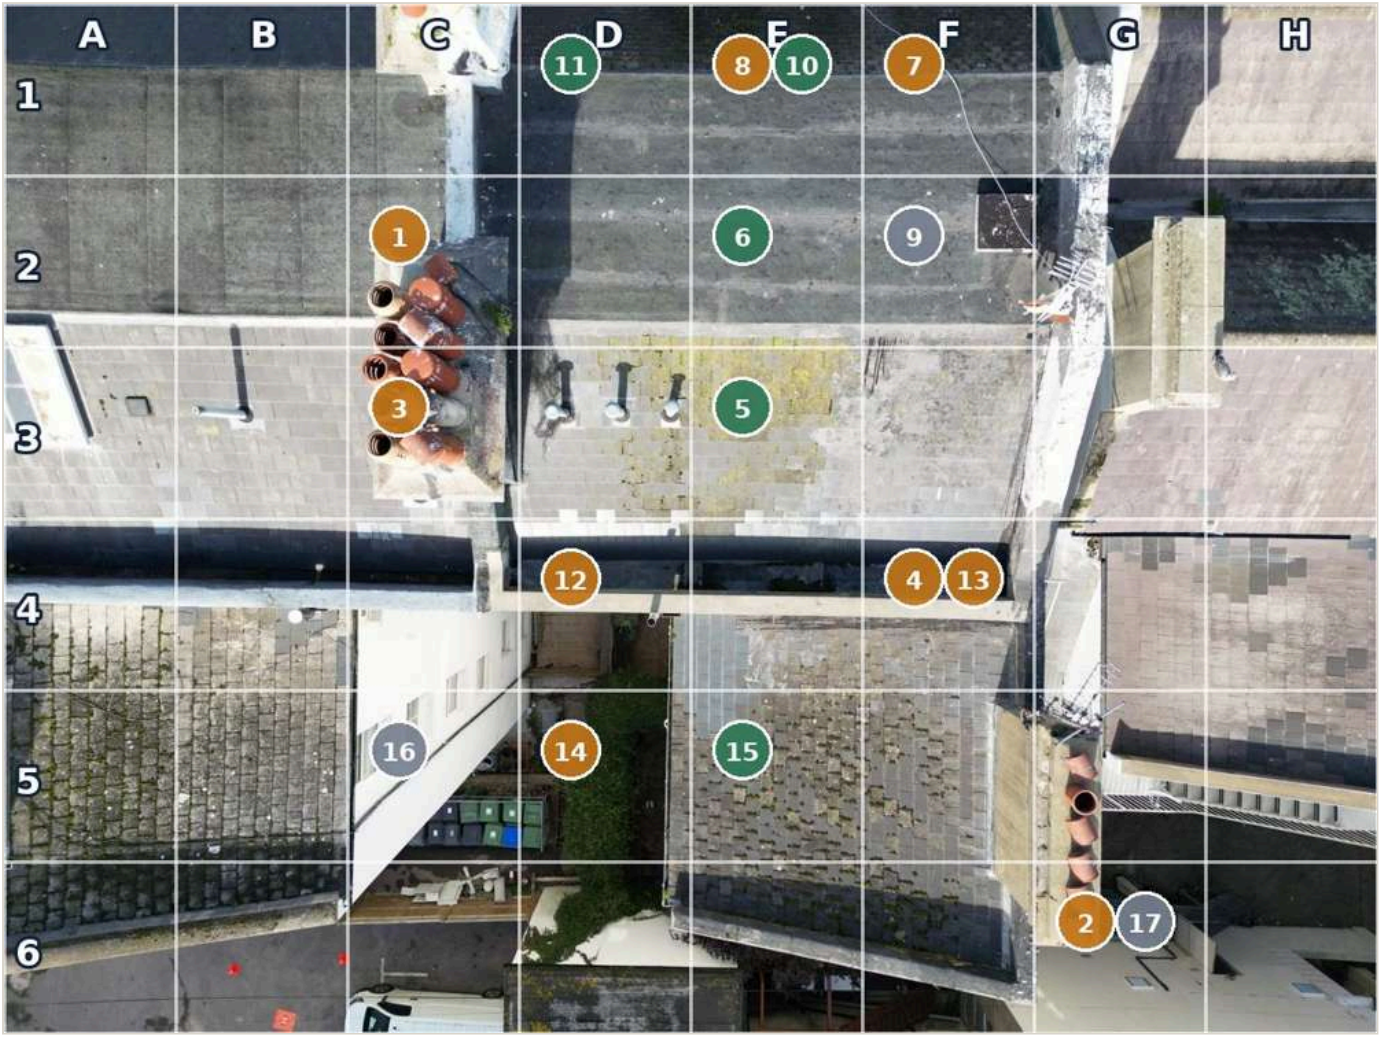
Vertical frame P001 with the 8 × 6 reference grid; numbered markers are the observations on page 3, coloured by rating. Elevation items (front bay roof, shop canopy) sit at the nearest roof cell.

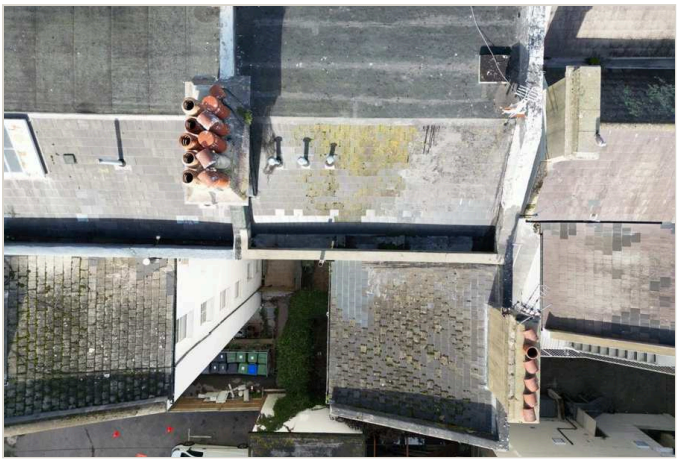
P001 · Vertical overview of both roofs; plan frame
P001_Overview_E2_OV.jpg

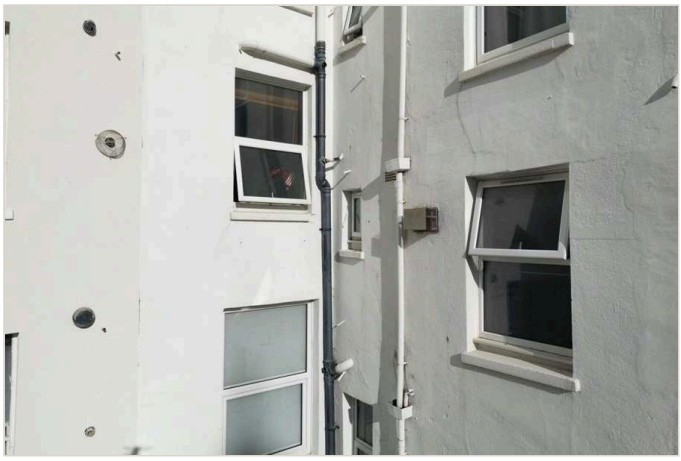
P009 · Plant growing from rear hopper; junctions on same run
P009_Rainwater-goods_D4_CR2.jpg
